## Machinery Messages Case History

# Monitoring for quality and safety in a pharmaceutical lab

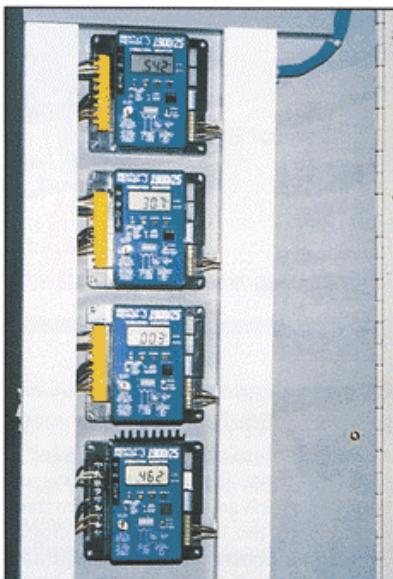
Figure 2  
Bently Nevada 1900/25 Monitors mounted in mechanical equipment room.

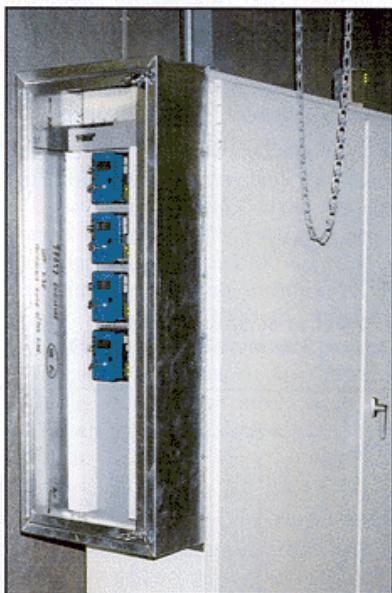
**Figure 3**  
Typical 1900/25 Monitor installation.  
Note strobe light on top of cabinet.

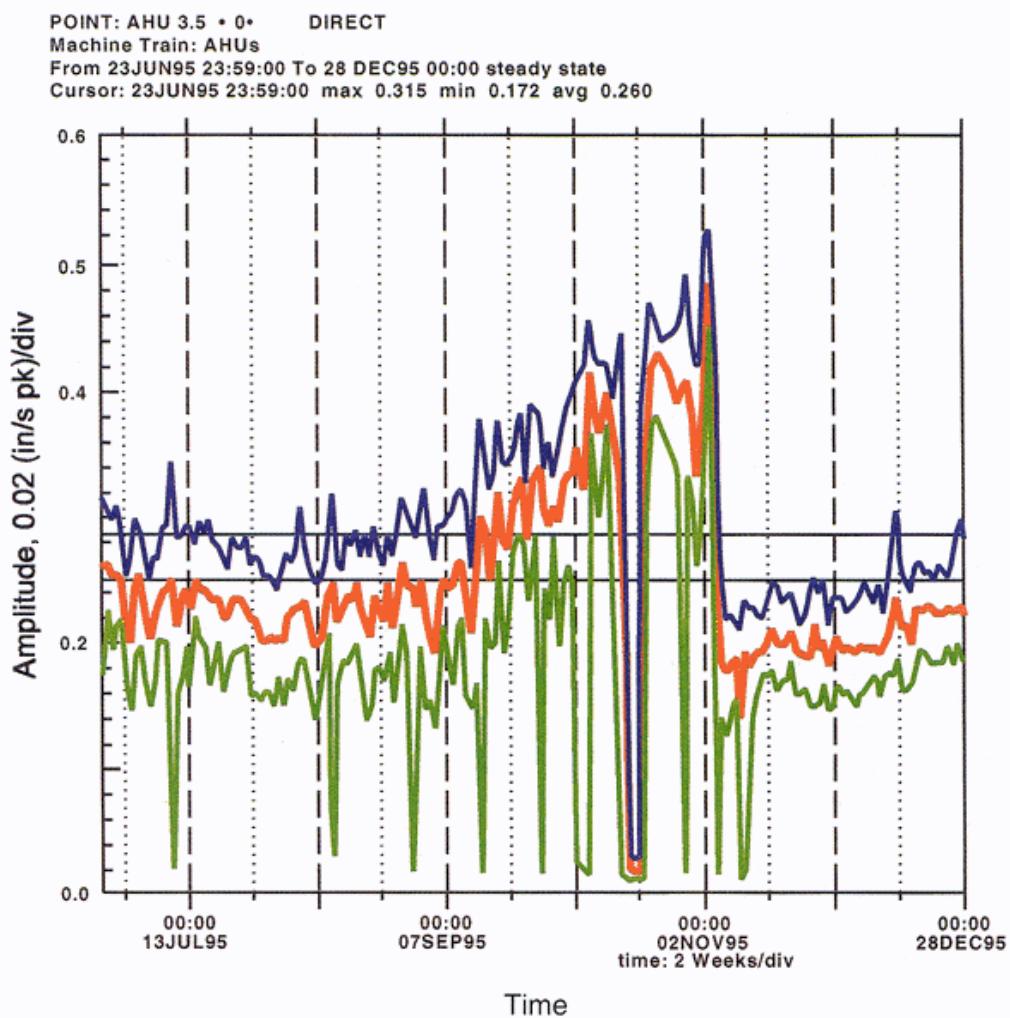
Vibration increased steadily on an Air Handler Unit, until an Alert alarm occurred. The critical machine couldn't be shut down immediately, so the condition was monitored closely until early November when a scheduled outage was planned. Although the vibration levels continued to rise (Figure 5), the unit was safely operated until a planned shut-

**Figure 5**  
Plot showing minimum, average and maximum vibration values of the Air Handler Unit.  
Note that the sudden decrease in amplitude after 2 November shows the effect of the balancing.

down was scheduled and the fan was examined. The diagnostic plots indicated an unbalance condition. Using this data, the machine was balanced. Afterward, vibration returned to an acceptable level.

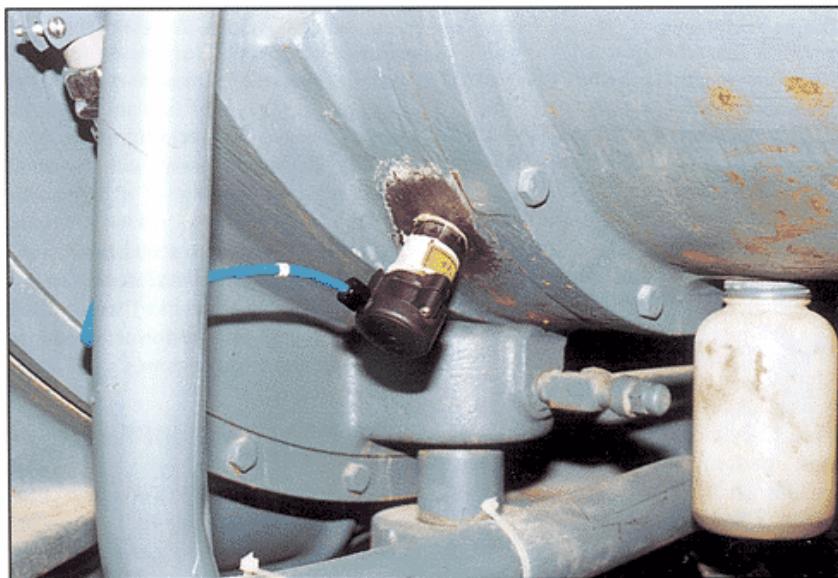
Epoxy-mounted accelerometer on a centrifugal chiller.
